# VOLVO PASSENGER SIDE 1

# VOLVO DRIVER SIDE1

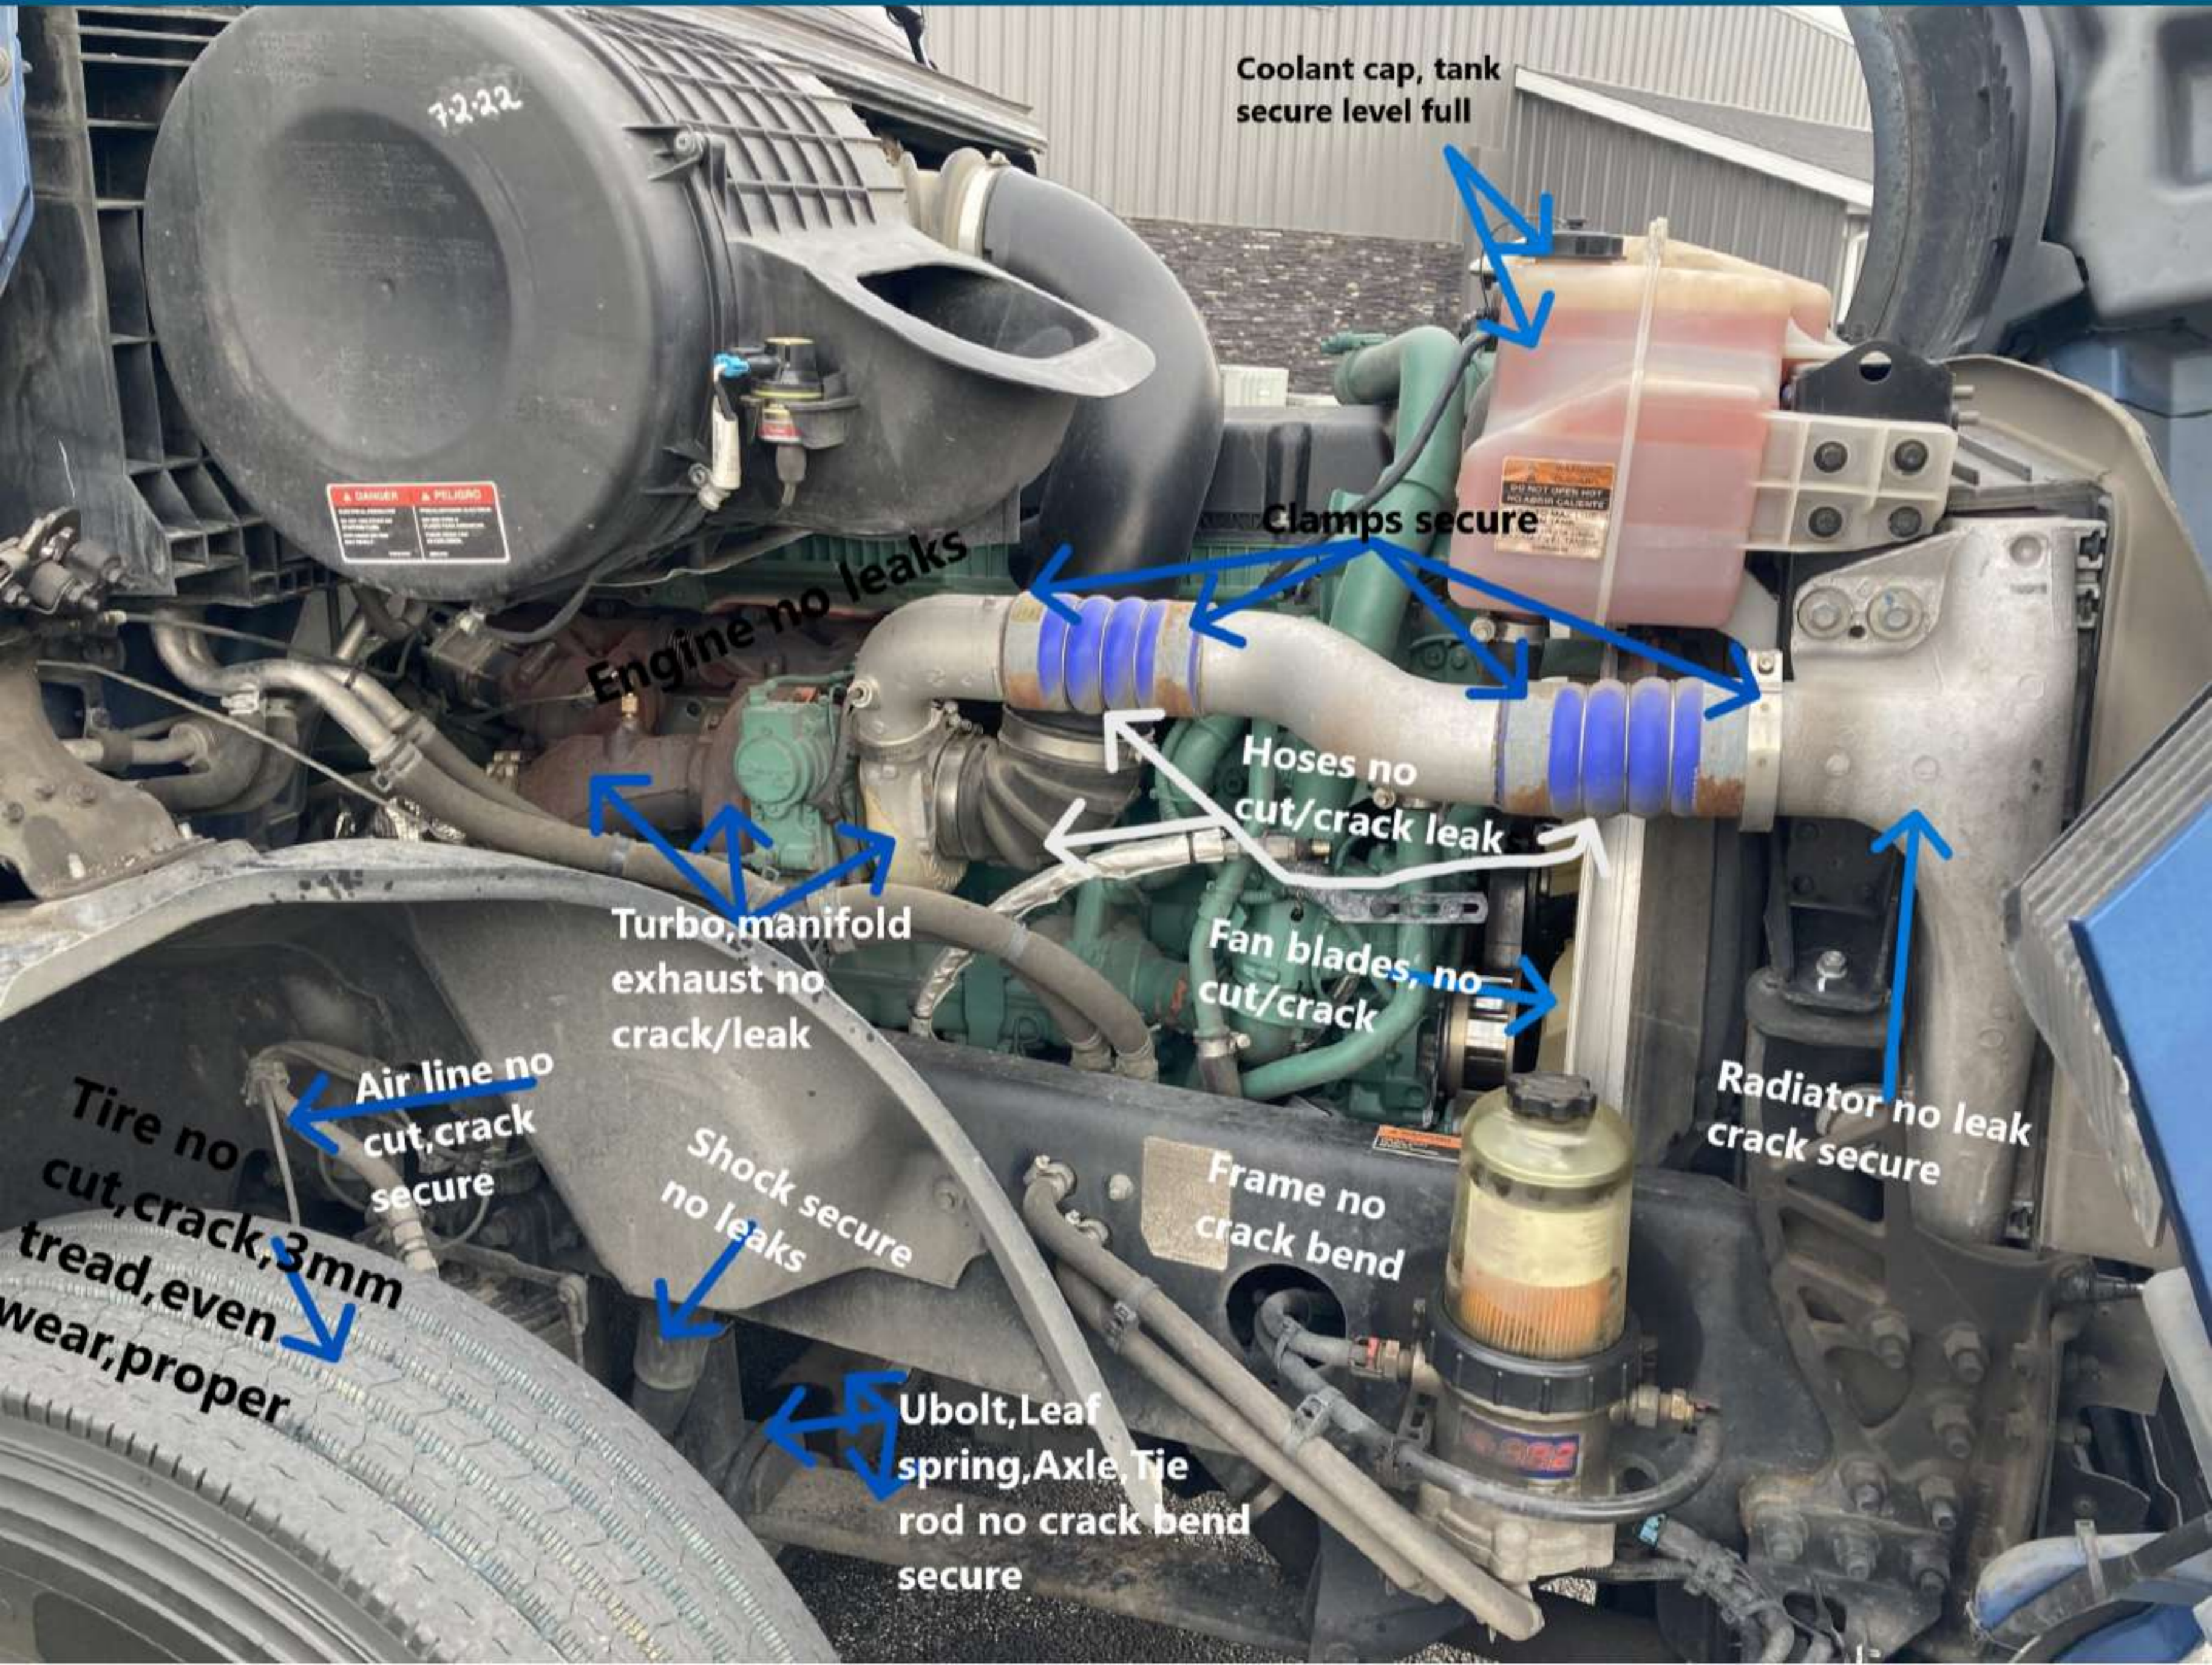
Coolant cap, tank  
secure level full

Clamps secure

Engine no leaks

Hoses no  
cut/crack leak

Turbo, manifold  
exhaust no  
crack/leak

Fan blades, no  
cut/crack

Radiator no leak  
crack secure

Air line no  
cut, crack  
secure

Shock secure  
no leaks

Frame no  
crack bend

Ubolt, Leaf  
spring, Axle, Tie  
rod no crack bend  
secure

Tire no  
cut, crack, 3mm  
tread, even  
wear, proper

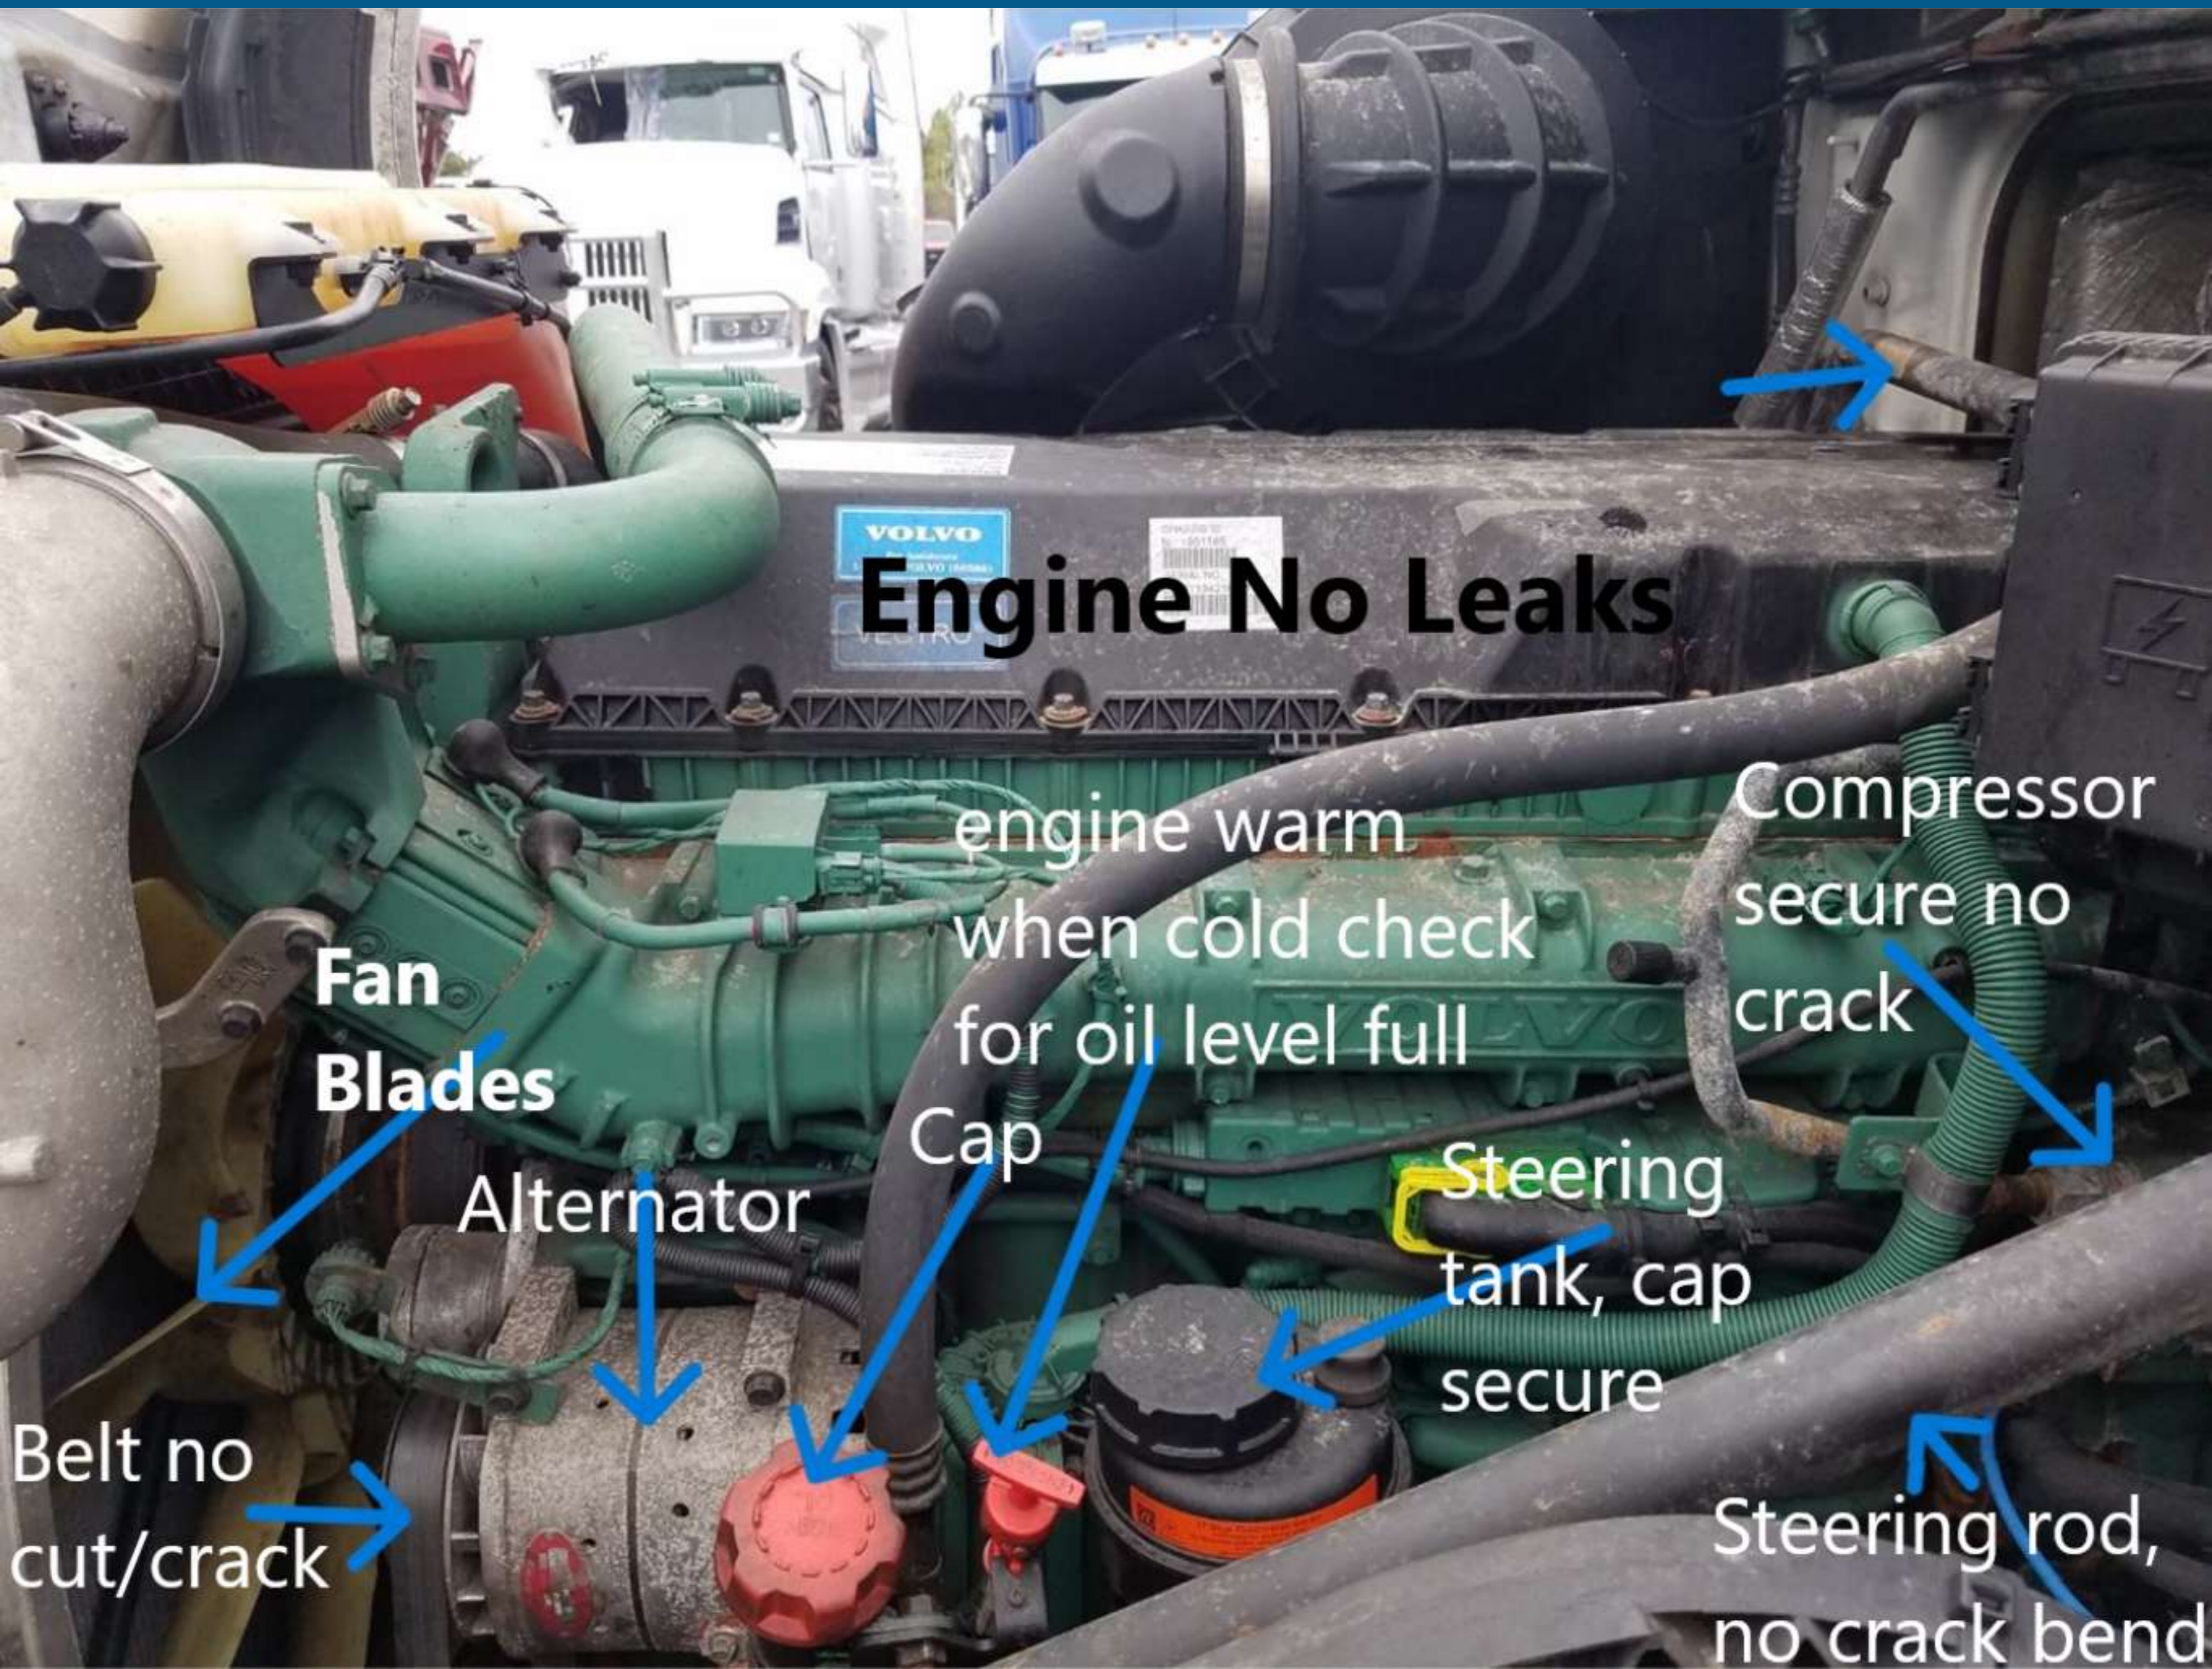
**Engine No Leaks**

engine warm  
when cold check  
for oil level full

Compressor  
secure no  
crack

**Fan  
Blades**

Alternator

Cap

Steering  
tank, cap  
secure

Belt no  
cut/crack

Steering rod,  
no crack bend
